Philips Norelco BeardTrimmer 3100 Blade Replacement

Removing the blades on the Philips Norelco 3100 BeardTrimmer.

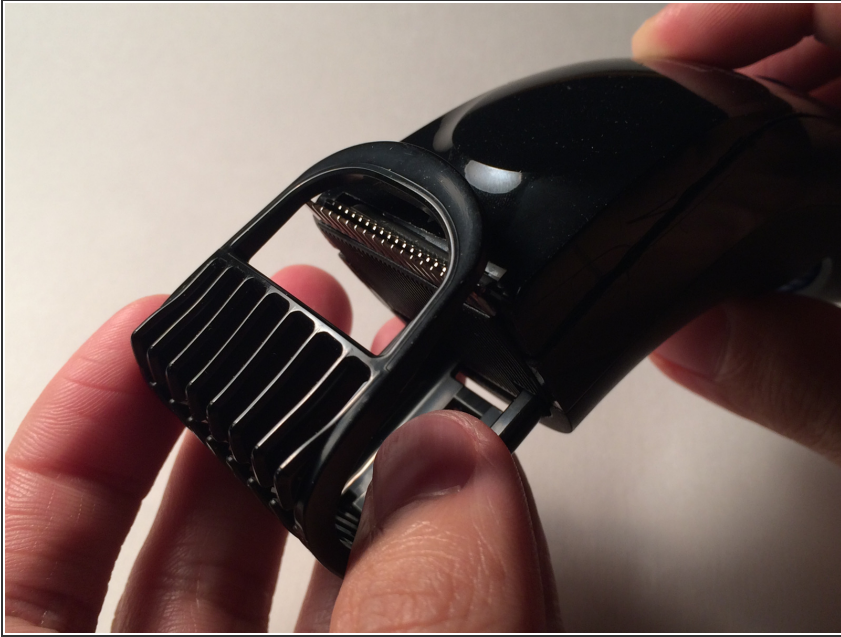
Step 1 — Blade

- Remove the comb from the head of the trimmer.

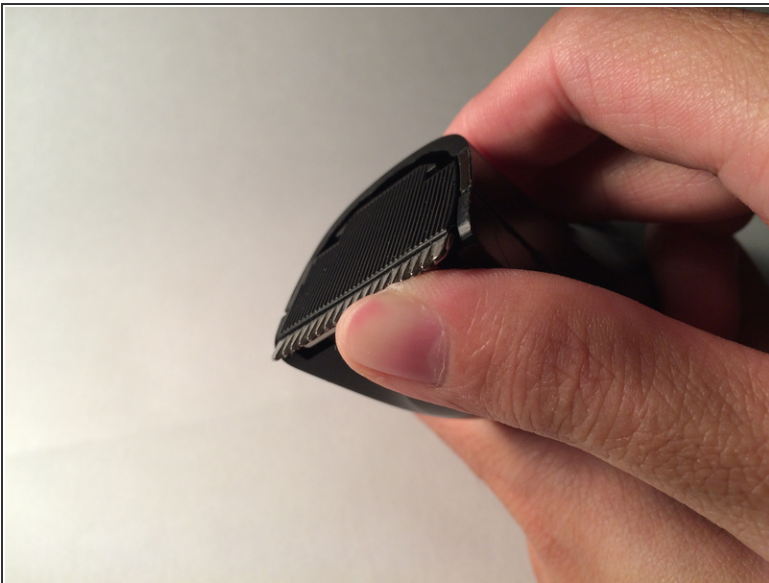
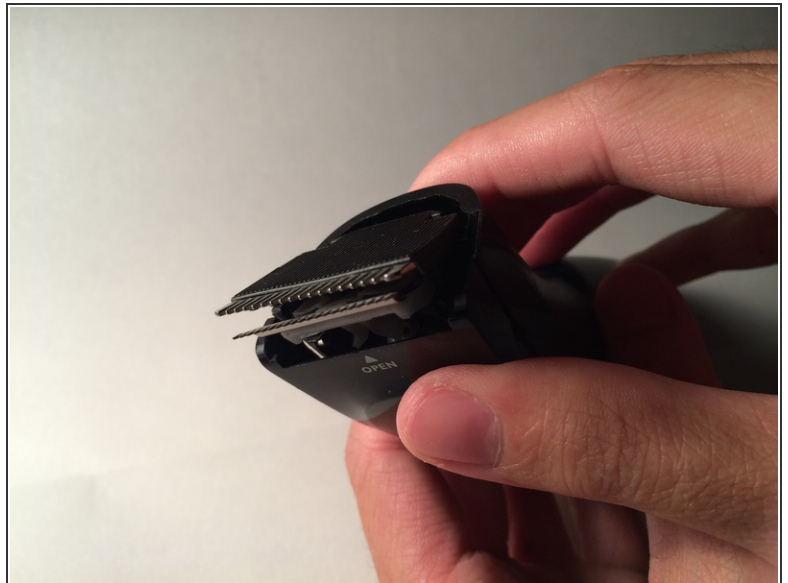
Step 2

- Place thumb underneath the blade; push upward to pop the blade off.
